April 7, 2023

MARSHALL MESA TRAILHEAD FIRE INVESTIGATION REPORT

File Name: Marshall Mesa Trailhead Fire
Date of Incident: December 30, 2021
Location: Intersection of Marshall Road (SH170), Eldorado Springs Drive, and Foothills Highway (SH93)
JH File Number: 1A3894001

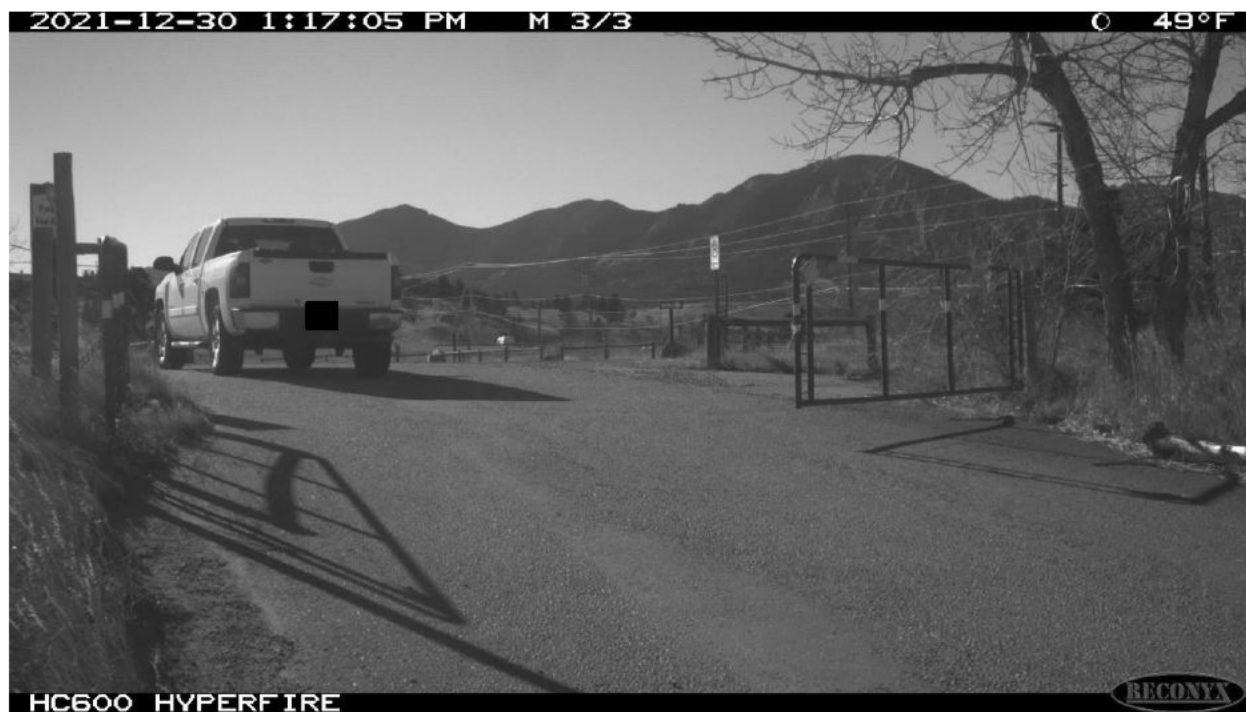
12:17:05 pm⁵ Gate Camera Pics, no fire recorded. Refer to Figure 8 and Figure 9
12:20:00 pm Gate Camera Pics smoke plume visible. Refer to Figure 10 through Figure 12
12:21 pm Mike Zoltowski video smoke plume present near MP2. Refer to Figure 14

Figure 9. Gate Camera Pics 0873. Time is actually 12:17:05pm

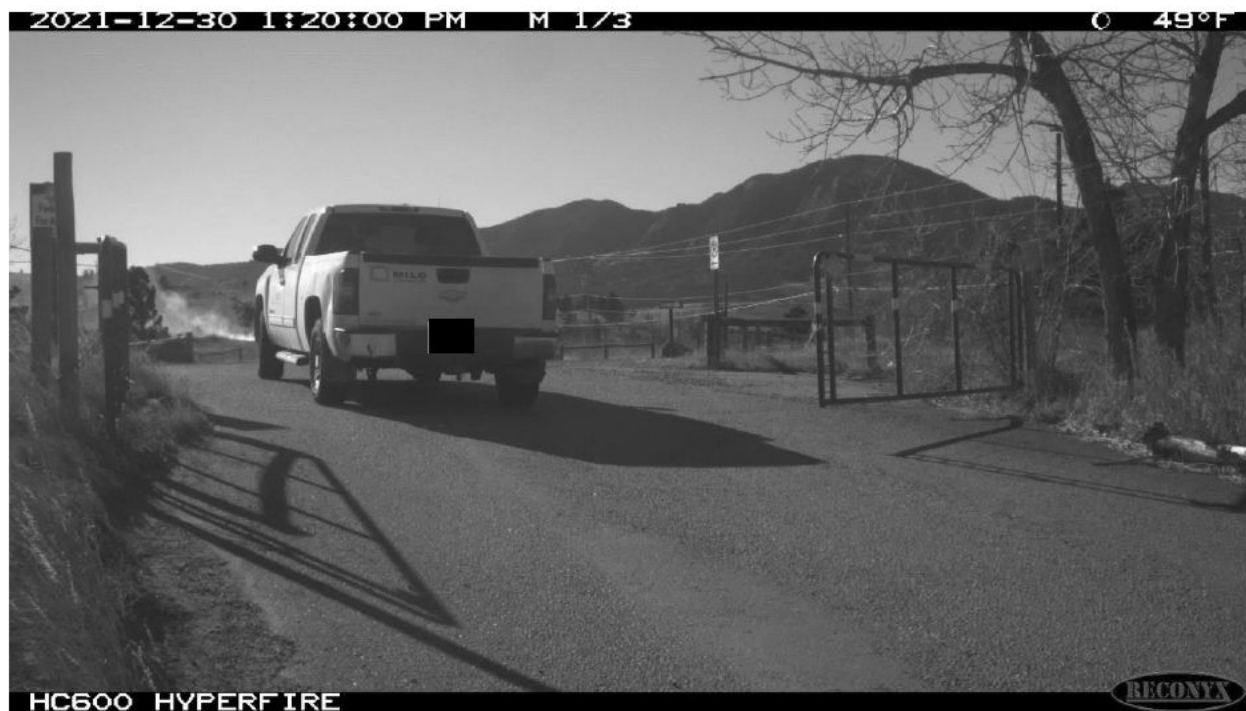
Figure 10. Gate Camera Pics 0874. Time is actually 12:20:00 pm.

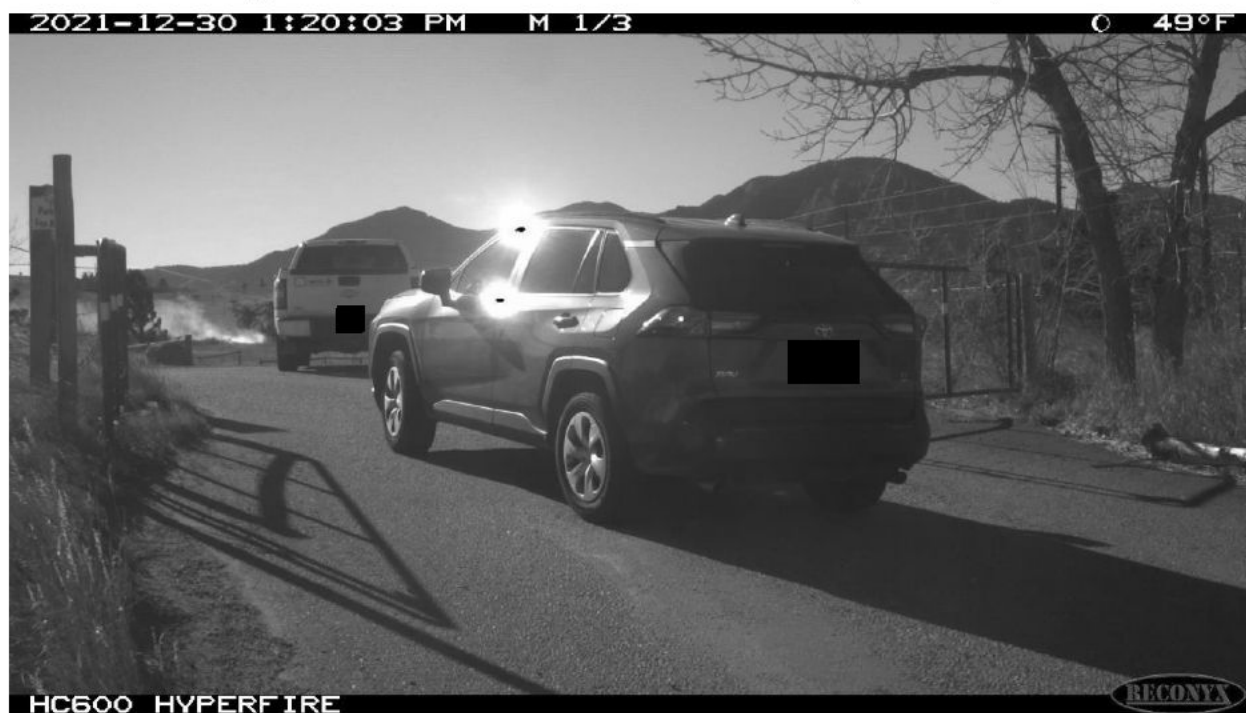
Figure 11. Gate Camera Pics 0877. Time is actually 12:20:03 pm.

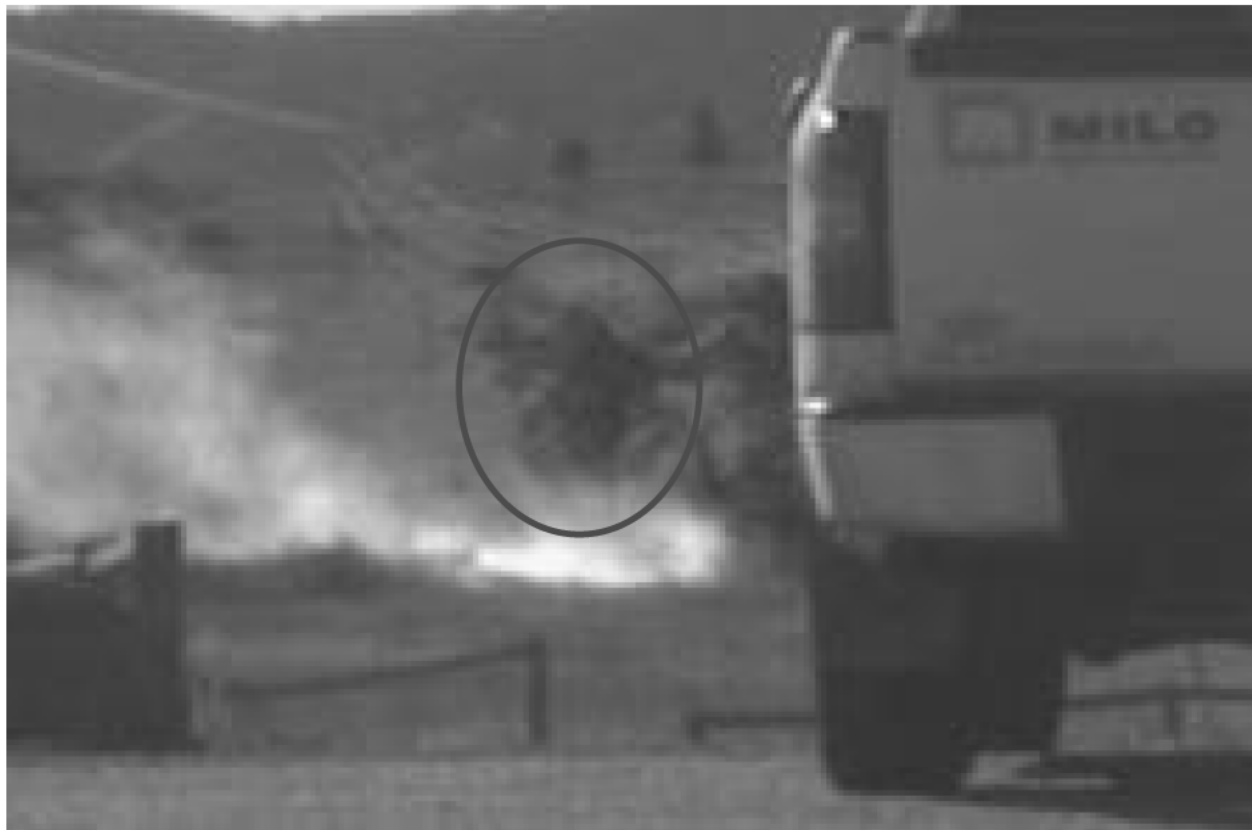
Circuit breaker 1161 opened and closed approximately 13 minutes before the smoke from the fire was first observed. The initial smoke plume and flames are in an area that matches the SAO #2 as shown in Figure 12 and Figure 13.

Figure 12. Gate Camera Pics 0877 enlarged. Note the tree indicated by the red circle.

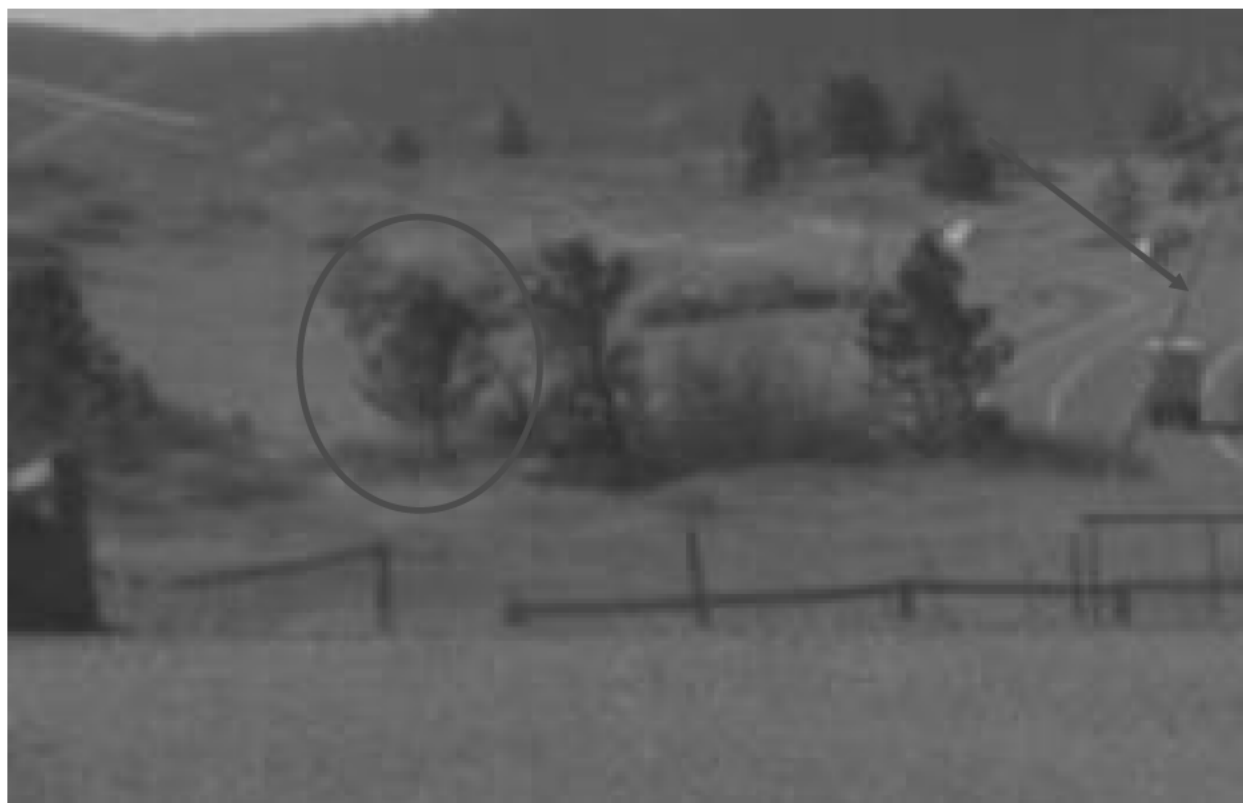
Figure 13. Gate Camera Pics 0815 enlarged and lightened. Note the tree shown in Figure 12 is also circled in red. Also, Xcel Energy pole MP2 is indicated by the red arrow.

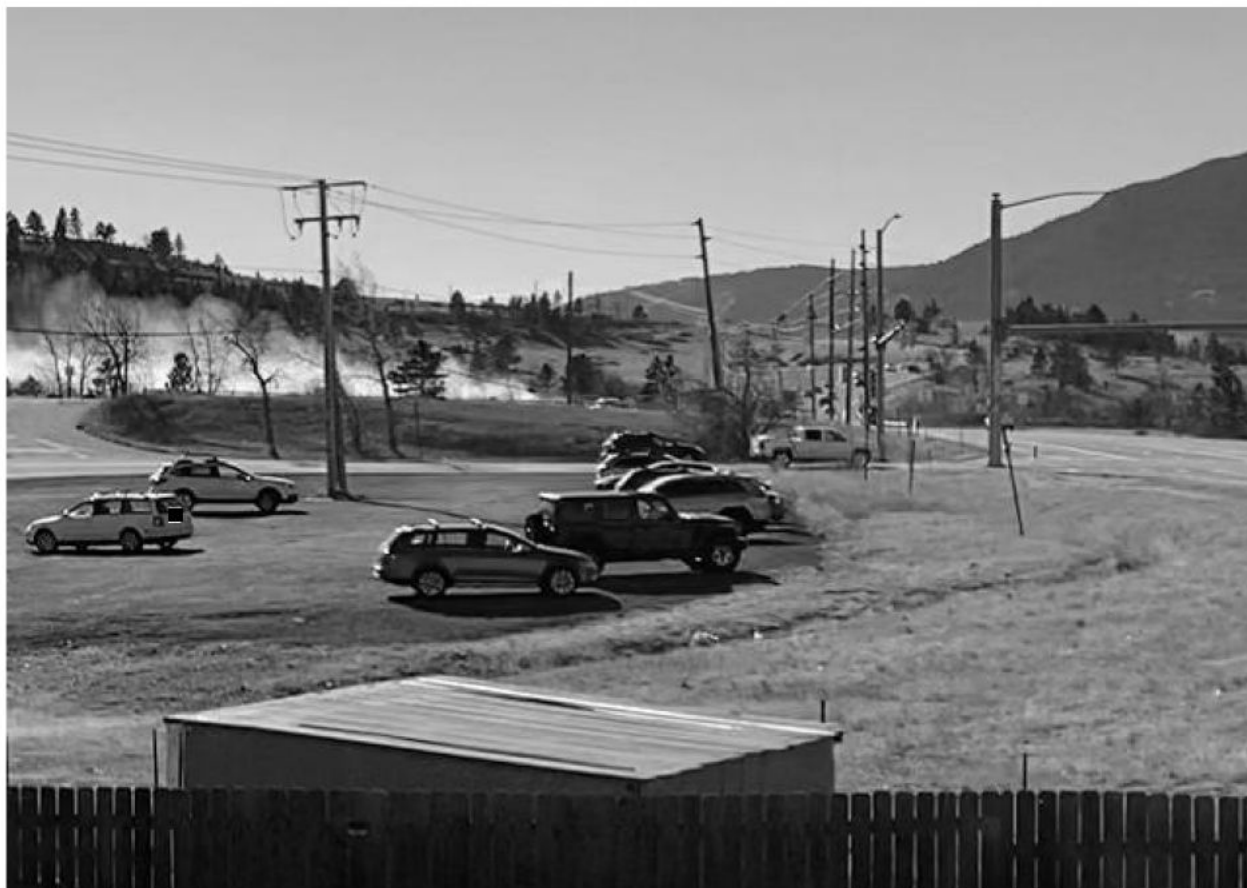
Figure 14. 12:21 pm Mike Zolowski video smoke plume present near MP2.

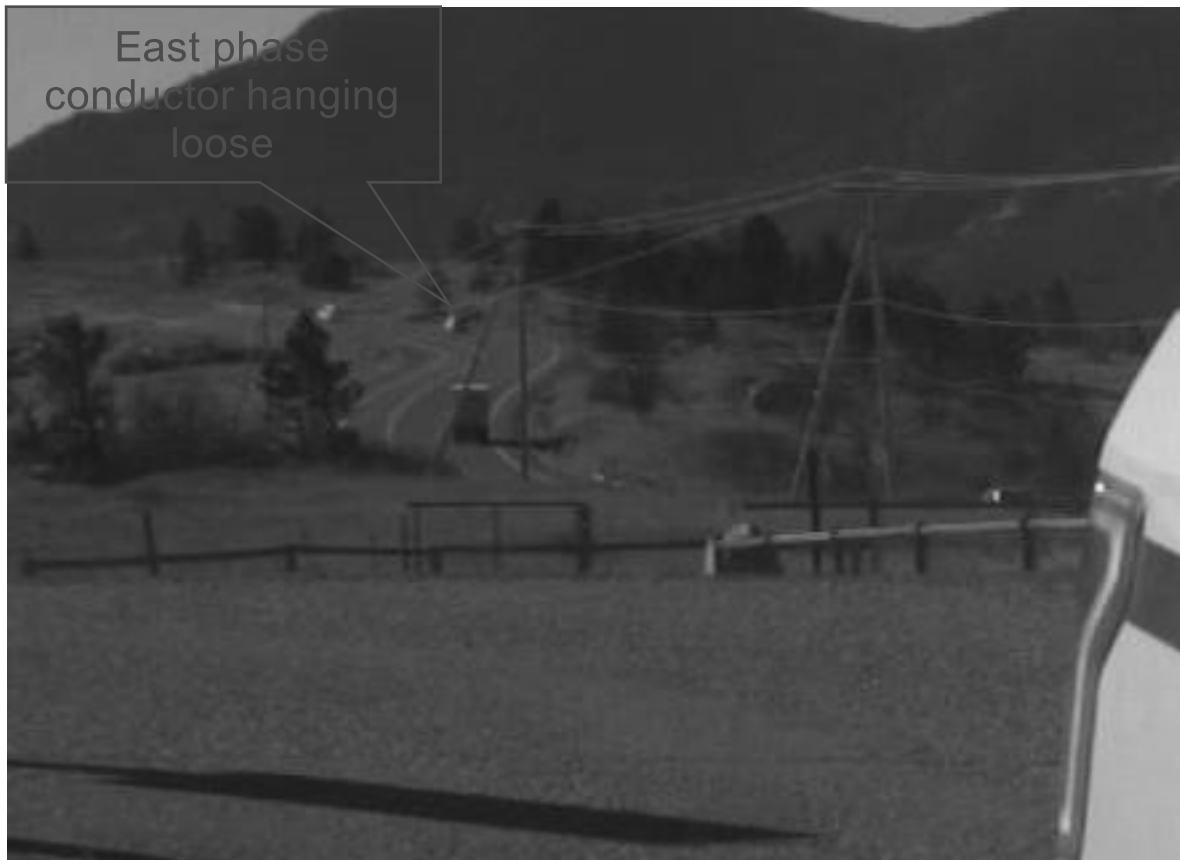
Figure 15. Gate camera folder 101REC/NX, IMG_0815, cropped and enlarged.

At the time that the fire originated at around 12:20:00 pm the eastern conductor at Pole MP2 had come loose from its insulator and was not attached to its insulator. The conductor was found hanging down in contact with the push pole brace (refer to Figure 15). Lashing wire remains for the eastern conductor were found on the ground underneath the conductors near the base of pole MP2.⁶

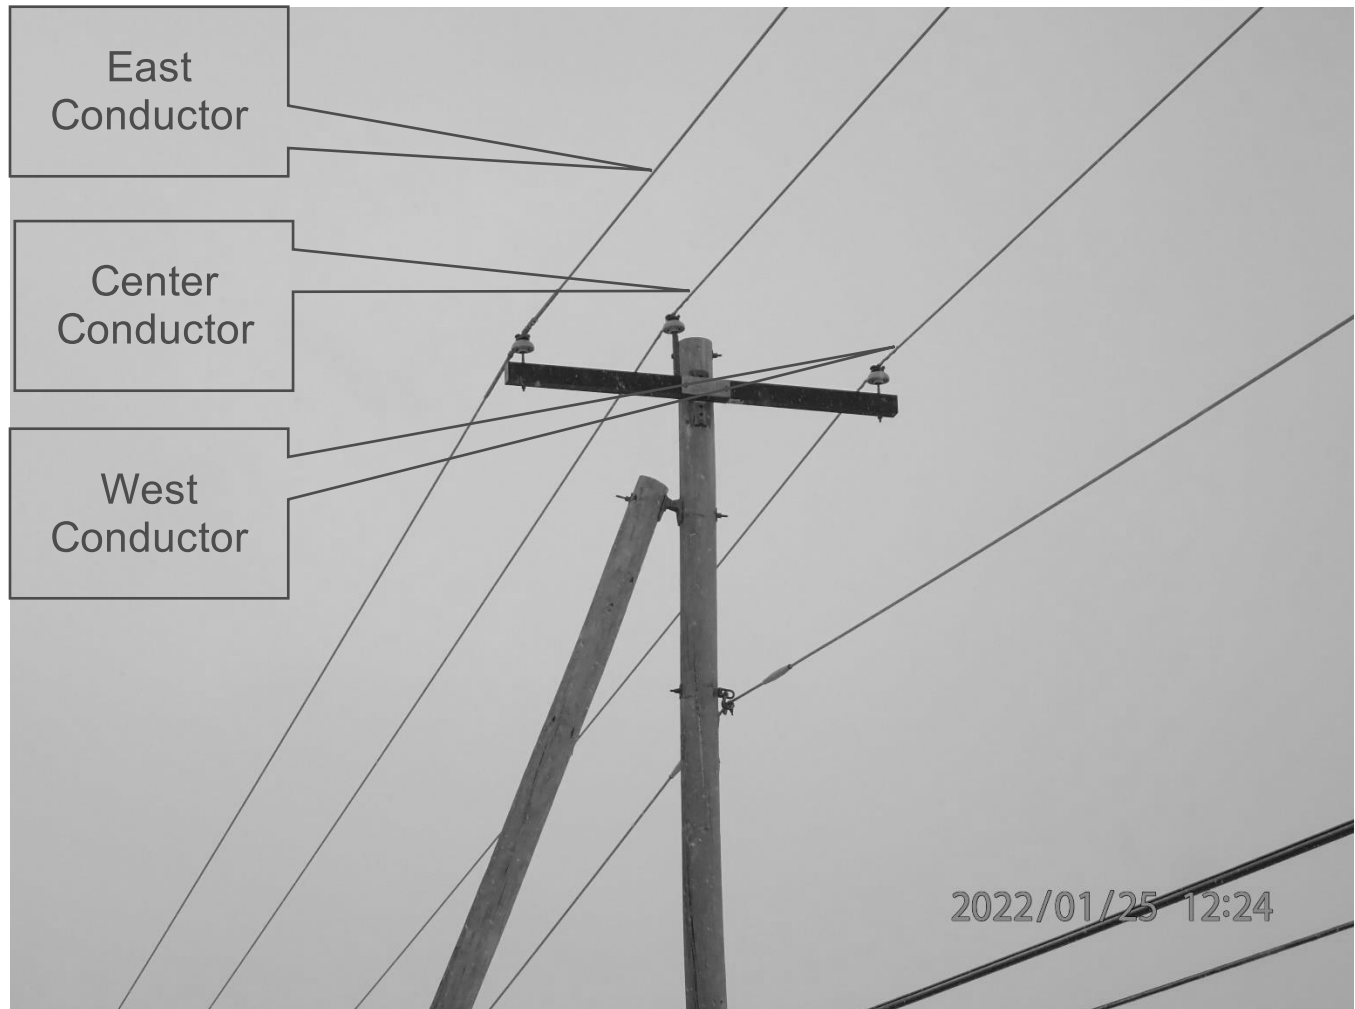
Figure 17. Top of pole MP2 that shows the three phase conductors mounted to the top of the crossarm and supported by pin type insulators. Pin insulators are designed to support conductors on their top surfaces. This image was taken facing southwest.

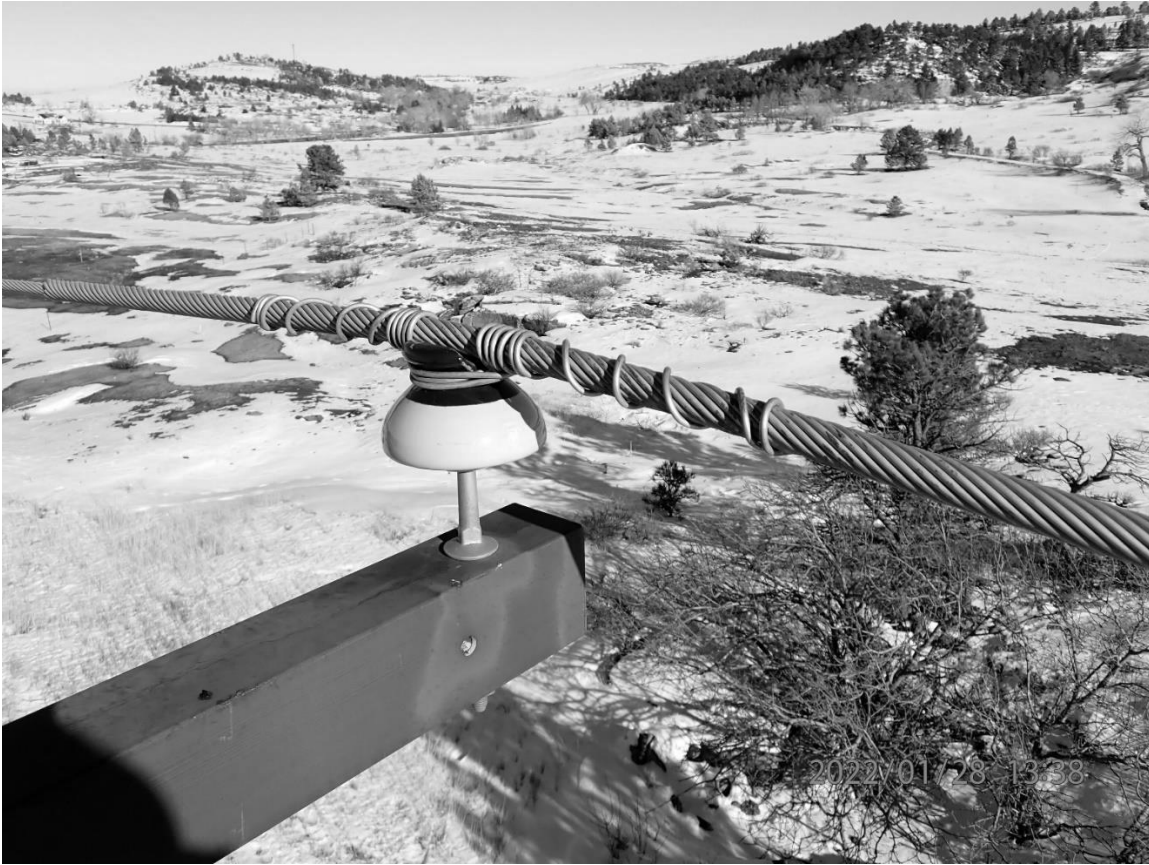
1. The fire in the area of the Marshall Mesa trailhead was ignited by hot aluminum particles produced when the east phase of Xcel Energy circuit 1161 came loose from its insulator and the lashing wire of the east phase contacted the center phase. The evidence examined revealed that the east phase had become detached from its insulator and that there was electrical arcing on the center phase conductor and on the lashing that had held the east phase to its insulator. The arcing on the east phase lashing and on the center phase conductor is conclusive evidence that the two conductors came into contact with each other and produced hot particles.

Figure 20. East phase conductor. Note that the lashing on this conductor had degraded and failed at the time of the fire and allowed the conductor to become displaced from the insulator. The lashing on the conductor was replaced after the fire.

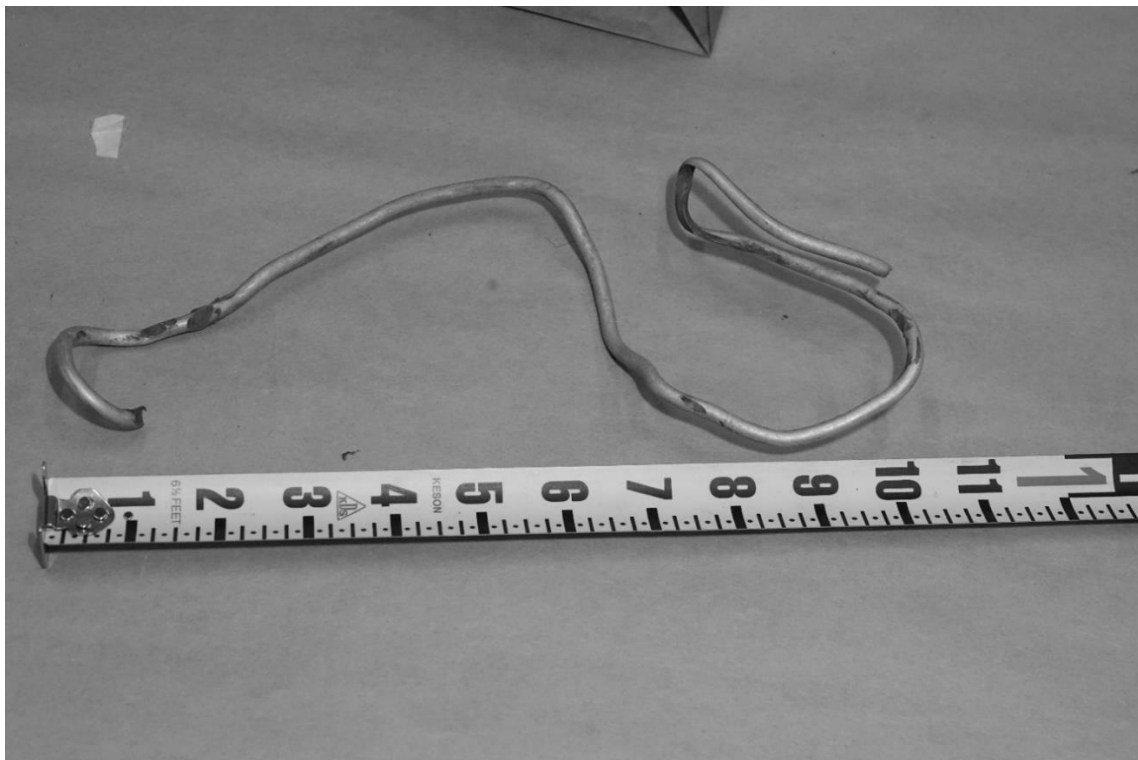
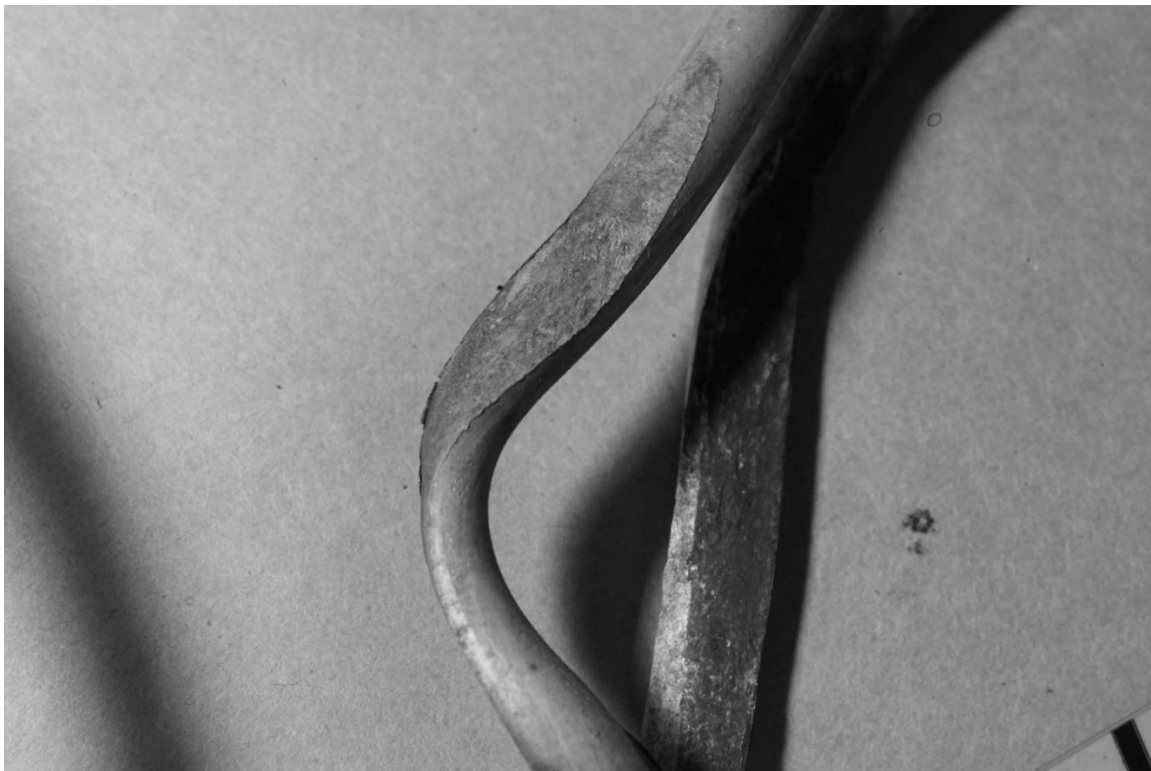
on the ground under the distribution line exhibited evidence of mechanical wear and electrical arcing (refer to Figure 21 and Figure 22).

Figure 21. Failed lashing from the east conductor with evidence of wear and electrical arcing.

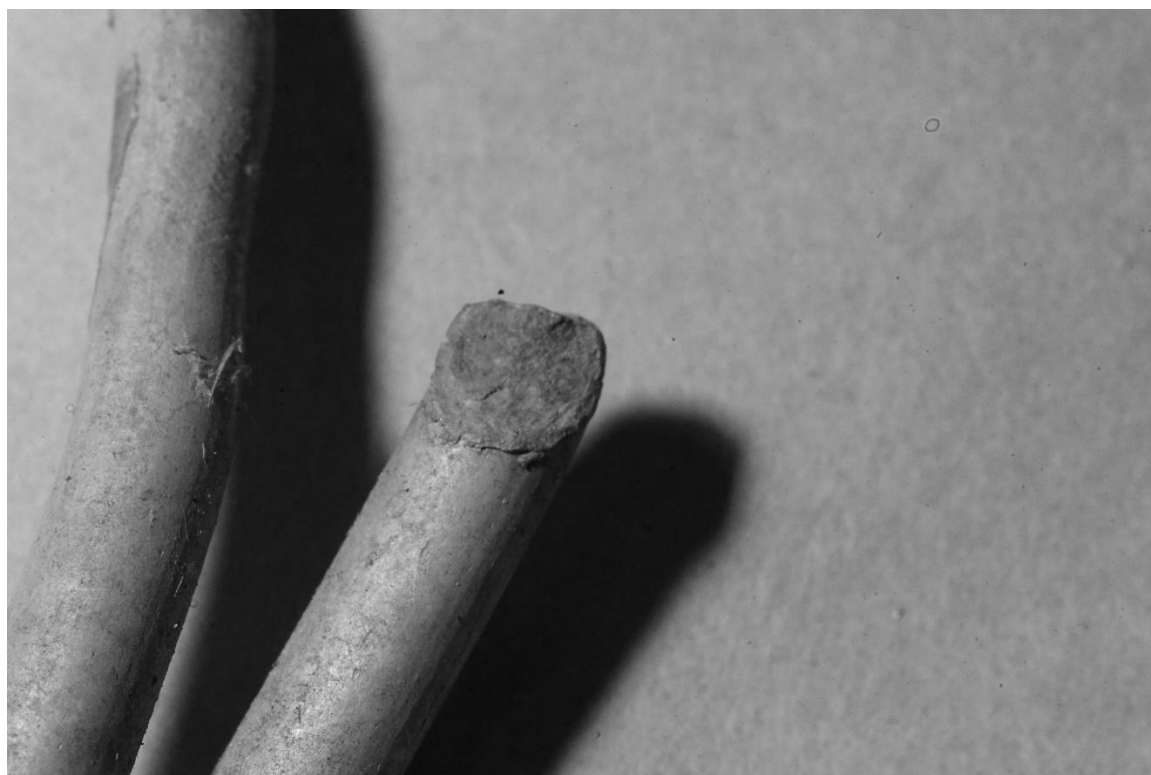
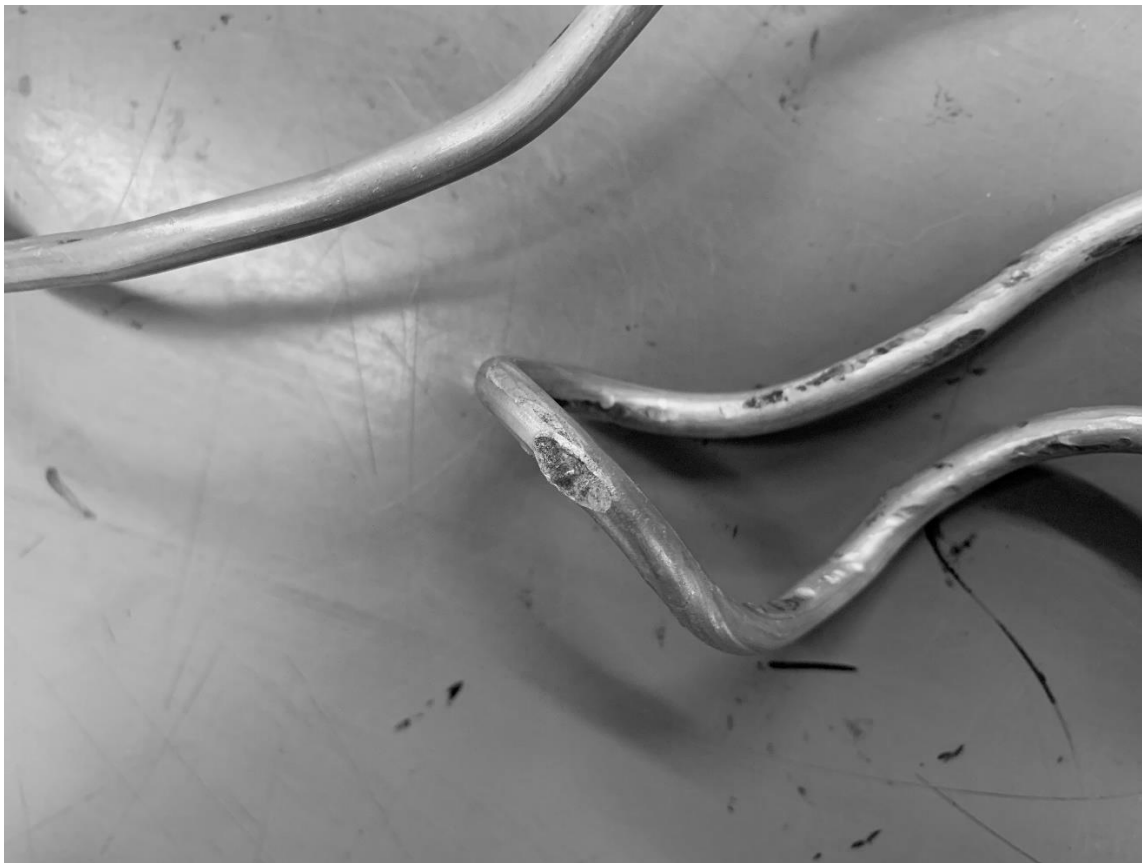
Figure 23. Evidence of electrical on the failed lashing.

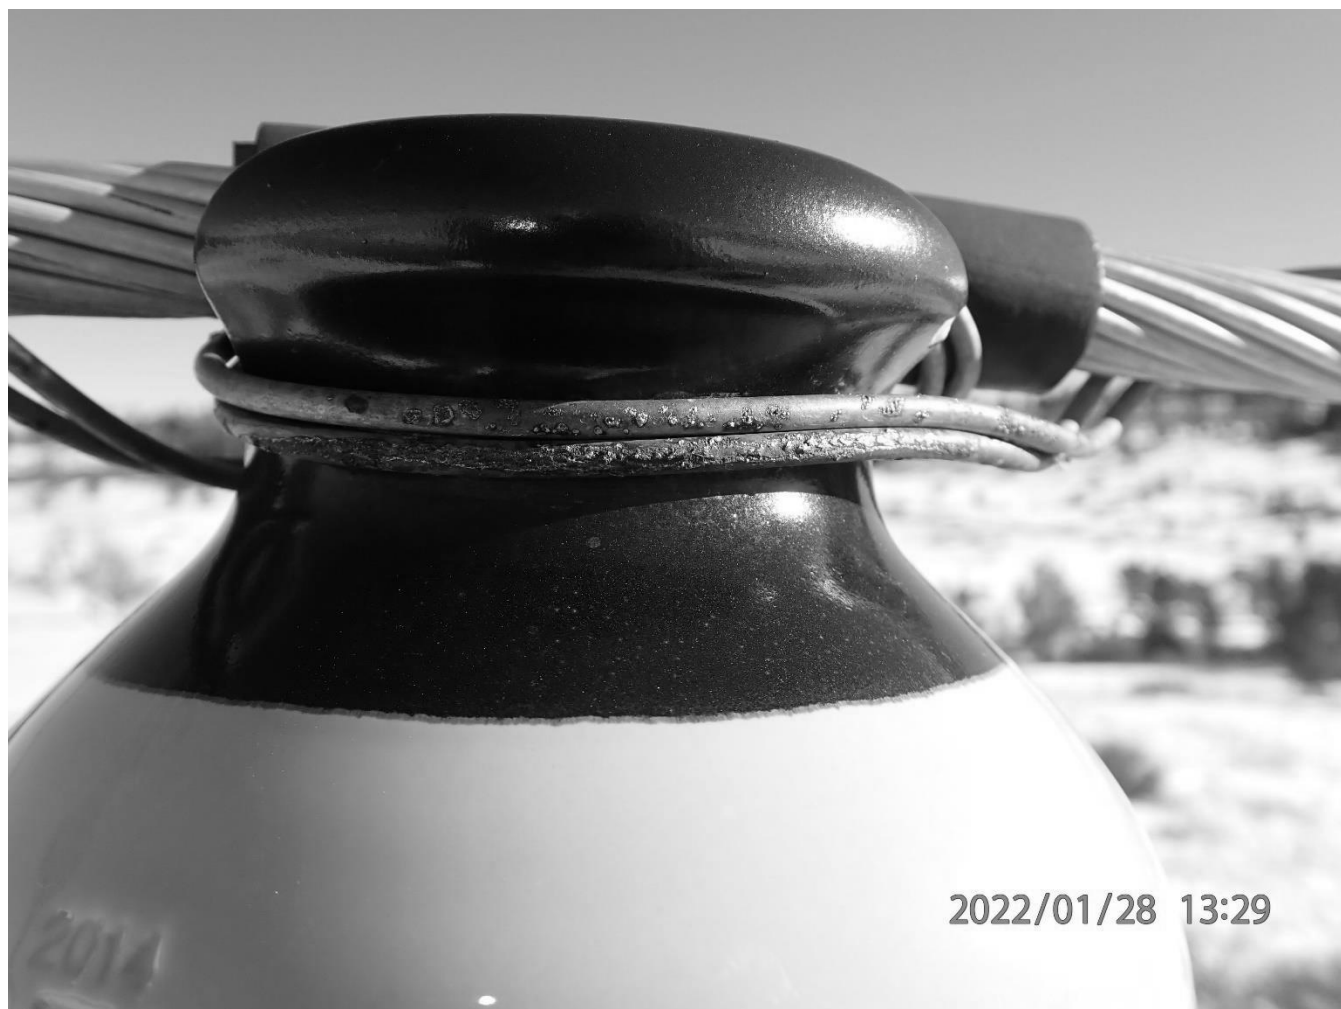
The conductors were examined in the field and in the Jensen Hughes laboratory. All conductors exhibited evidence of electrical arcing (refer to Figure 26 through Figure 31). One area of the center conductor was missing a large (a few grams) particle of aluminum conductor (refer to Figure 28, Figure 30, and Figure 31). Furthermore, arc damage was observed on the lashing that had held the eastern conductor in place and the arcing would have contributed hot material to the hot particle production. Prior testing done by Jensen Hughes has shown that a hot particle with a mass of a few grams would have been large enough, hot enough, and near enough to a susceptible fuel bed to create ignition.

Figure 26. West phase insulator. Note evidence of electrical arcing on the lashing.

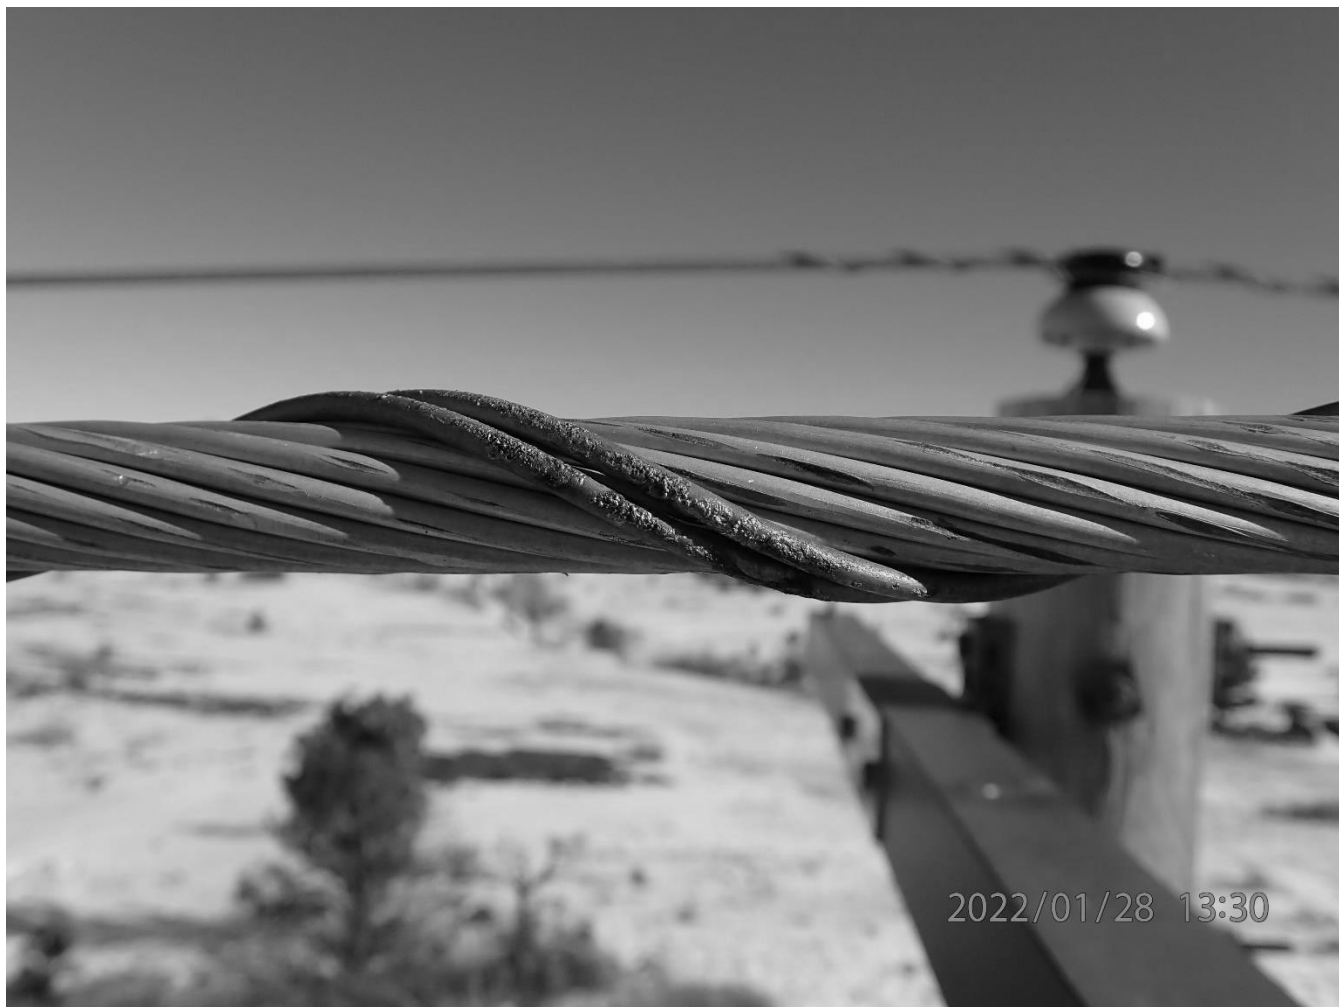
Figure 27. West Phase conductor with arc damage.

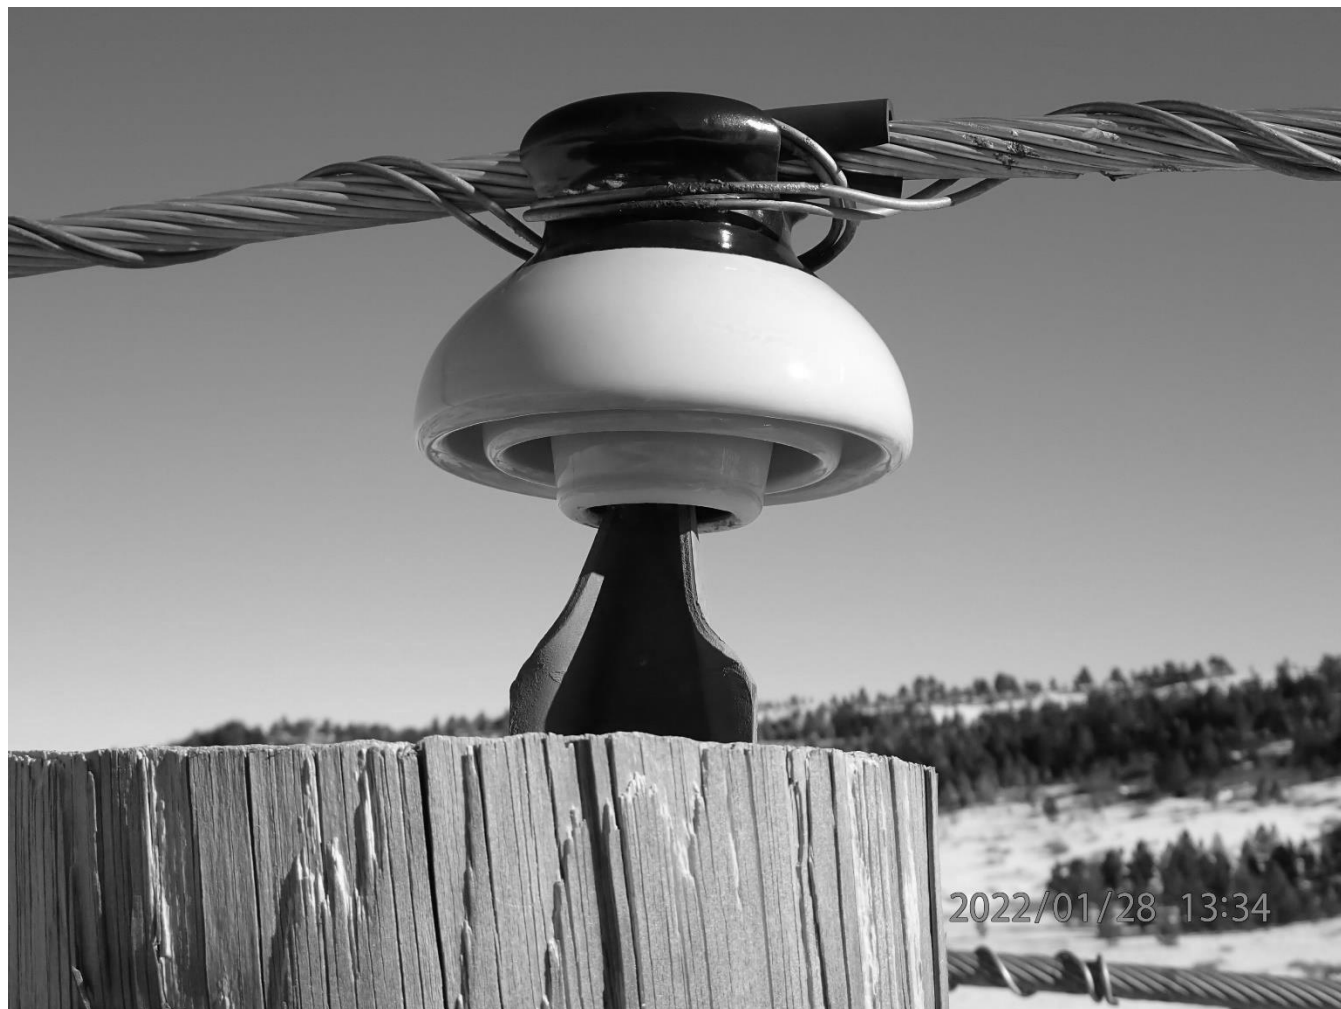
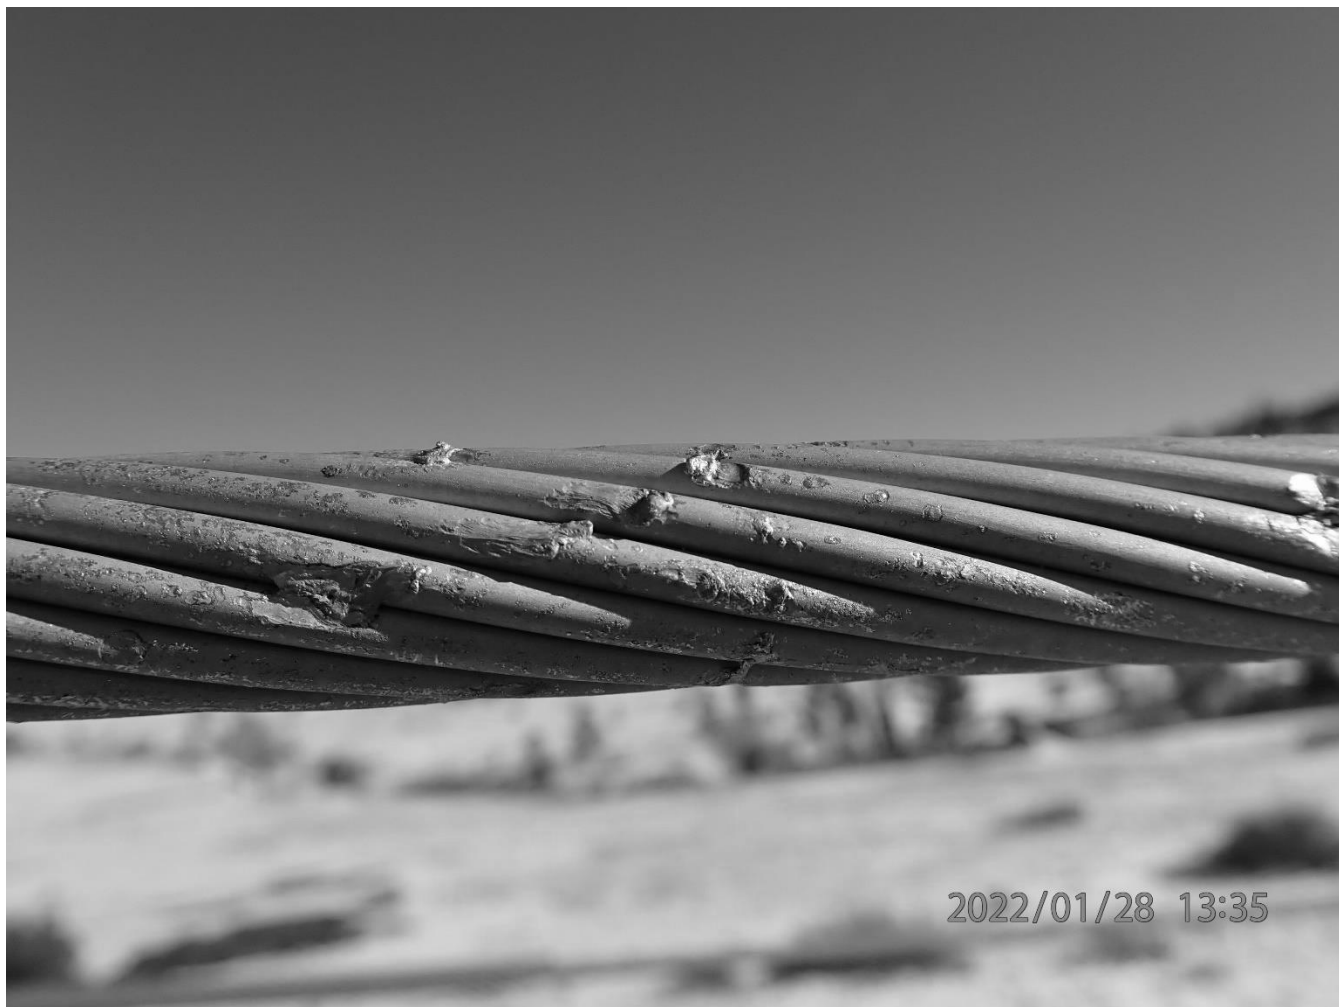
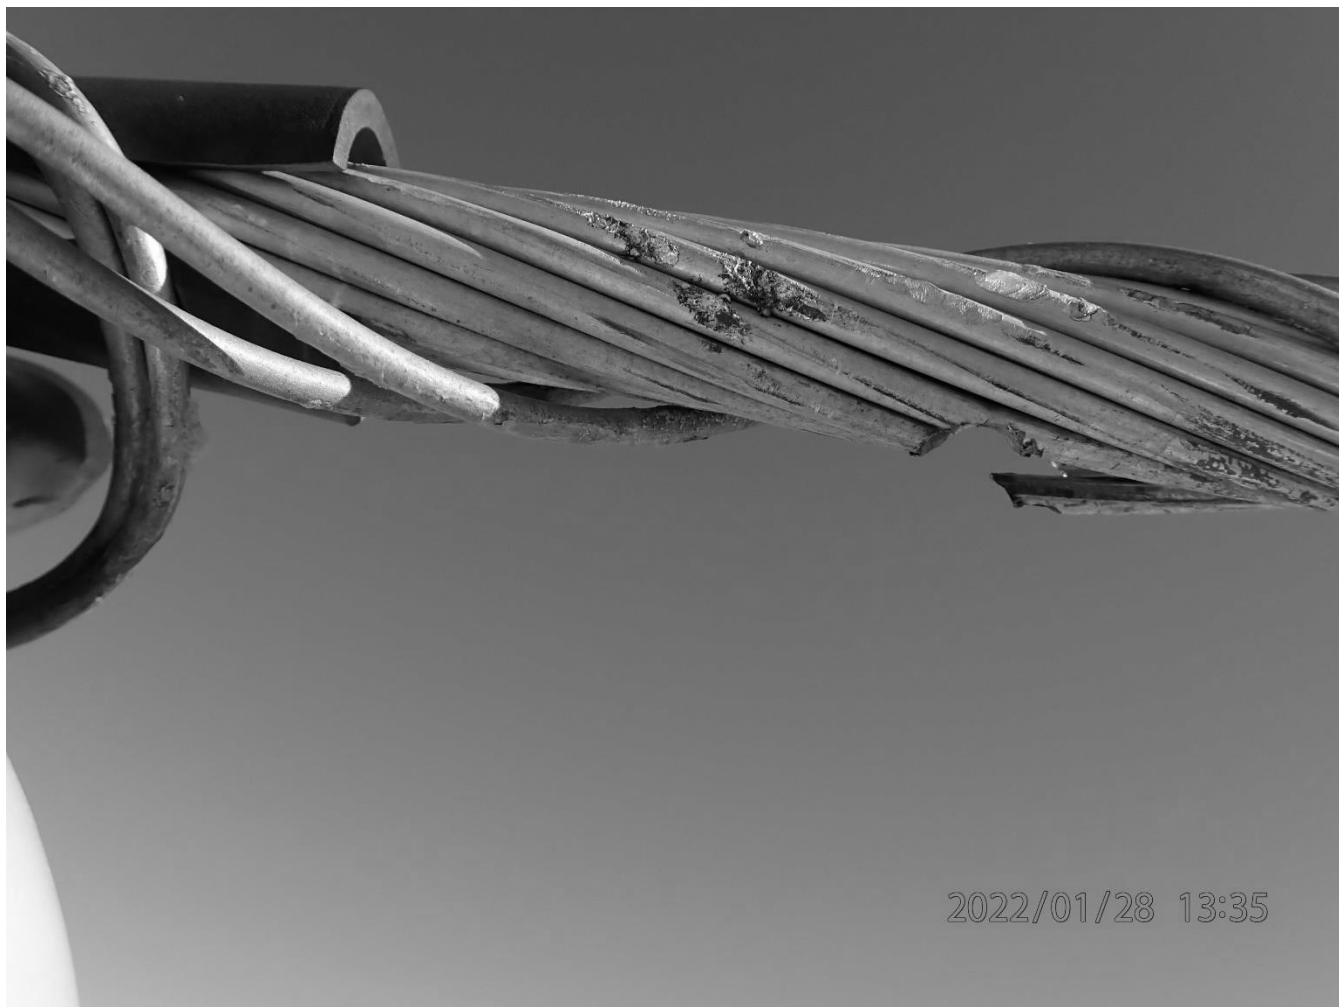
Figure 29. Arc evidence on the center phase conductor.

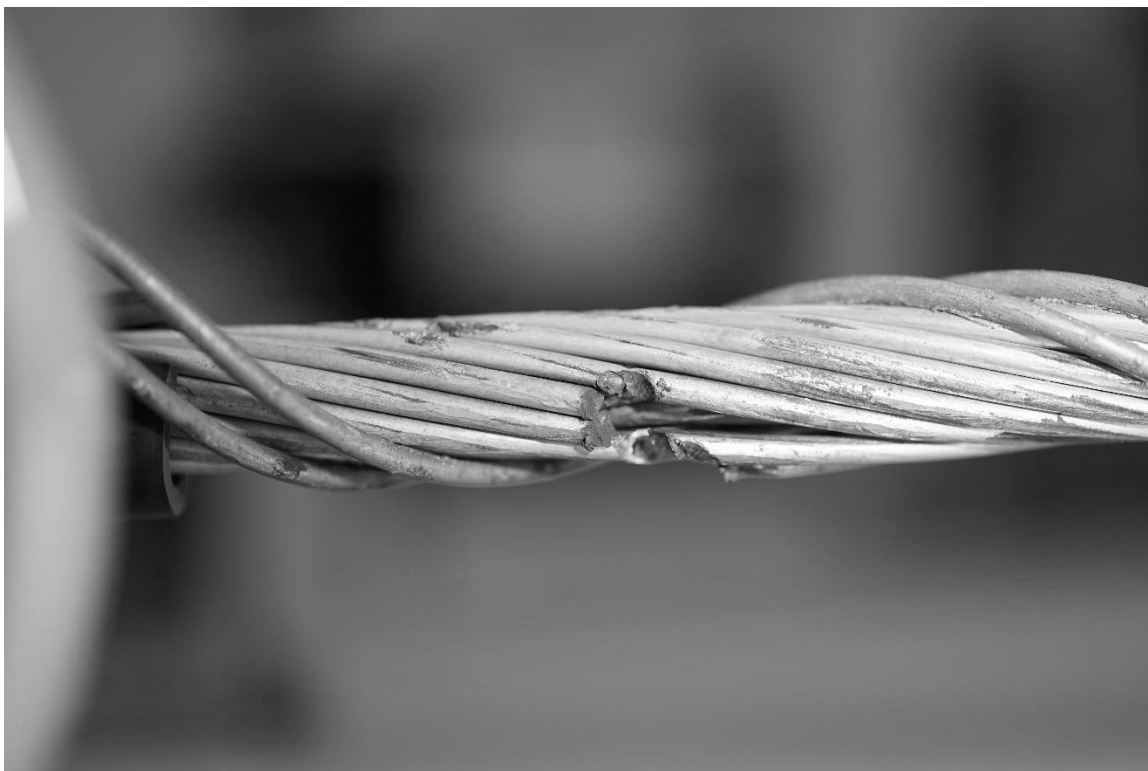
Figure 31. Electrical arcing on the center phase conductor.
