April 7, 2023

MARSHALL MESA TRAILHEAD FIRE INVESTIGATION REPORT

File Name: Marshall Mesa Trailhead Fire
Date of Incident: December 30, 2021
Location: Intersection of Marshall Road (SH170), Eldorado Springs Drive, and Foothills Highway (SH93)
JH File Number: 1A3894001

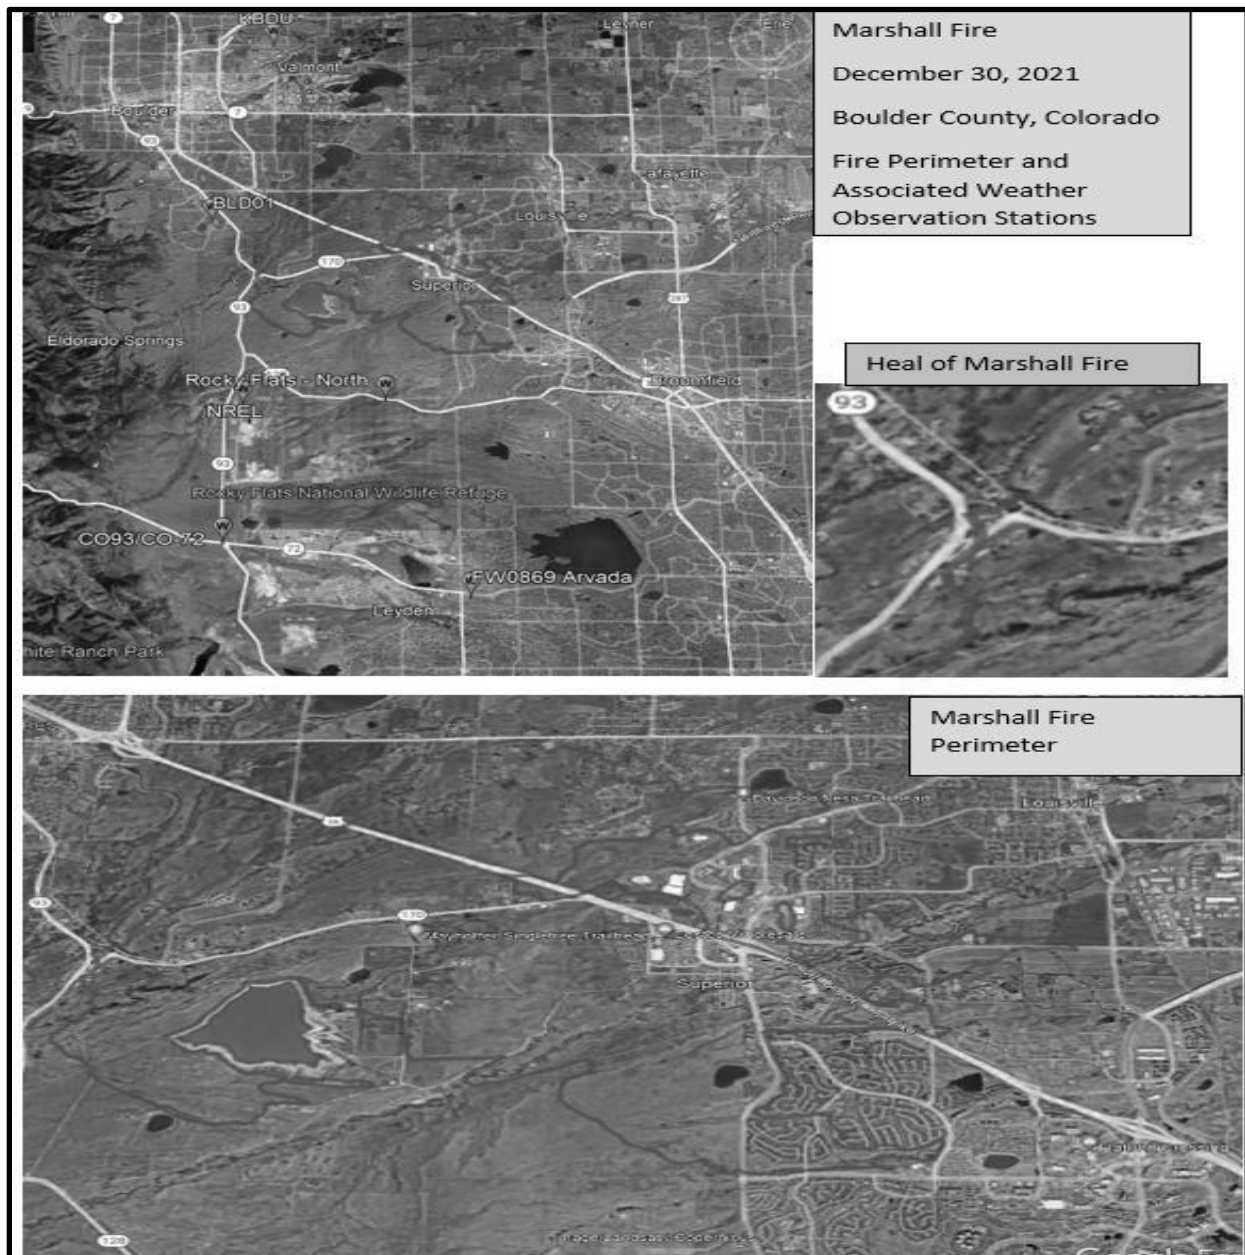
Figure 2. Excerpt from the Wildland Fire Origin and Cause Supplemental Incident Report, page 16.

The USDA Forest Service “Wildland Fire Origin and Cause Supplemental Incident Report” (referred to as the FS O&C Report in this report) included a number of descriptive fire scene sketches on pages 16-20 which are included below as Figure 2 through Figure 5. The Marshall fire had three origin points. Referring to Figure 5 below, SAO #1 and SAO #2, were near and downwind from the Xcel Energy pole identified during preliminary investigation as “Pole MP2.” Subsequent investigation revealed that “Pole MP2” was identified by Xcel Energy as Pole Number 432056196. For ease of reference, I will refer to the pole as Pole MP2.

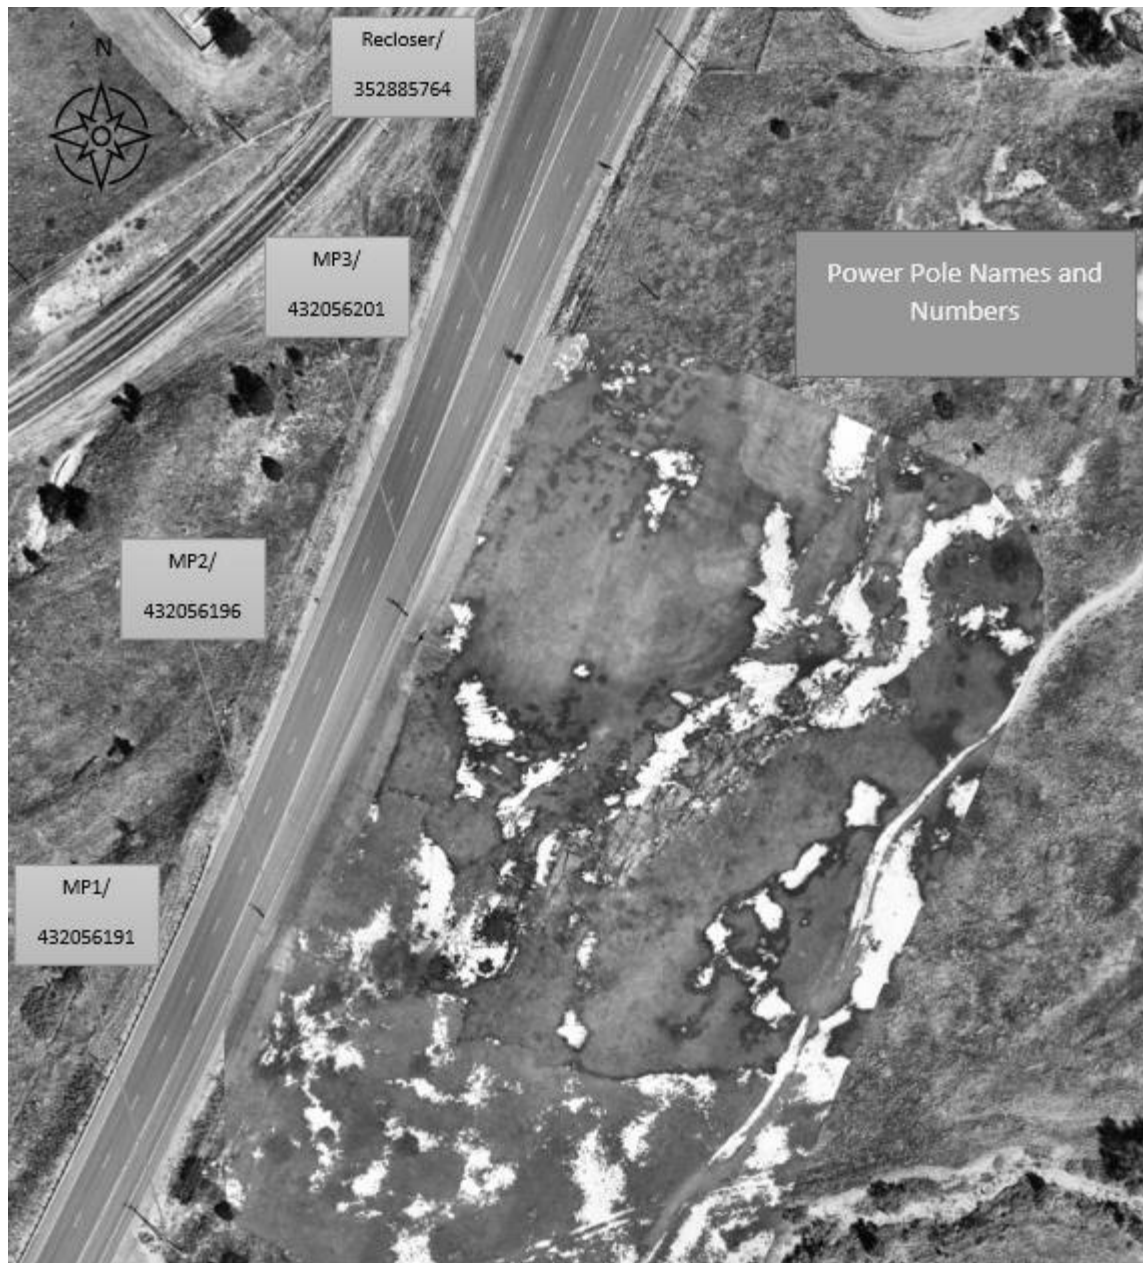
Figure 4. Excerpt from the Wildland Fire Origin and Cause Supplemental Incident Report, page 20.

The electrical distribution circuit in the area of the Marshall Mesa Trailhead was identified by Xcel as the Eldorado 13.8kV circuit 1161. The Eldorado circuit 1161 was protected by two devices. The circuit breaker and associated relay that provided primary protection for the circuit was located in the Eldorado substation. The second circuit protection device was recloser 101-507 which was immediately adjacent to the area of the Marshall Mesa Trailhead (refer to Figure 4.)

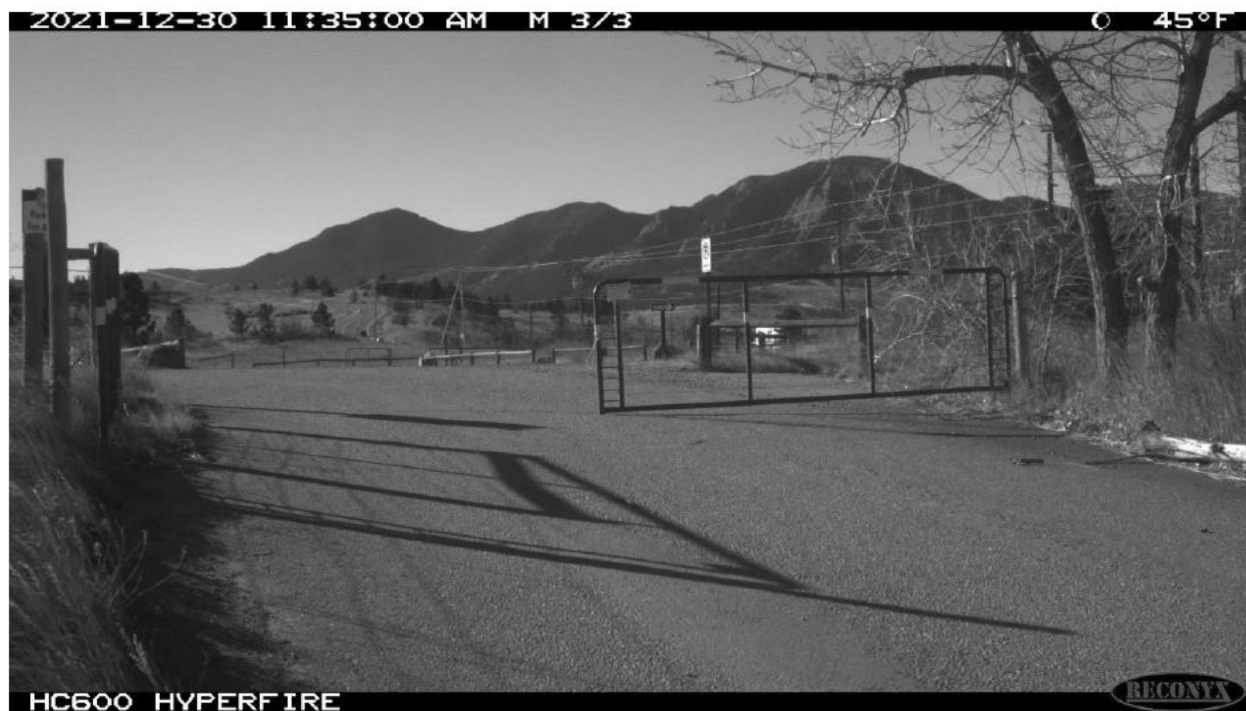
Figure 8. Gate Camera Pics 0810

12:17:05 pm⁵ Gate Camera Pics, no fire recorded. Refer to Figure 8 and Figure 9
12:20:00 pm Gate Camera Pics smoke plume visible. Refer to Figure 10 through Figure 12
12:21 pm Mike Zoltowski video smoke plume present near MP2. Refer to Figure 14

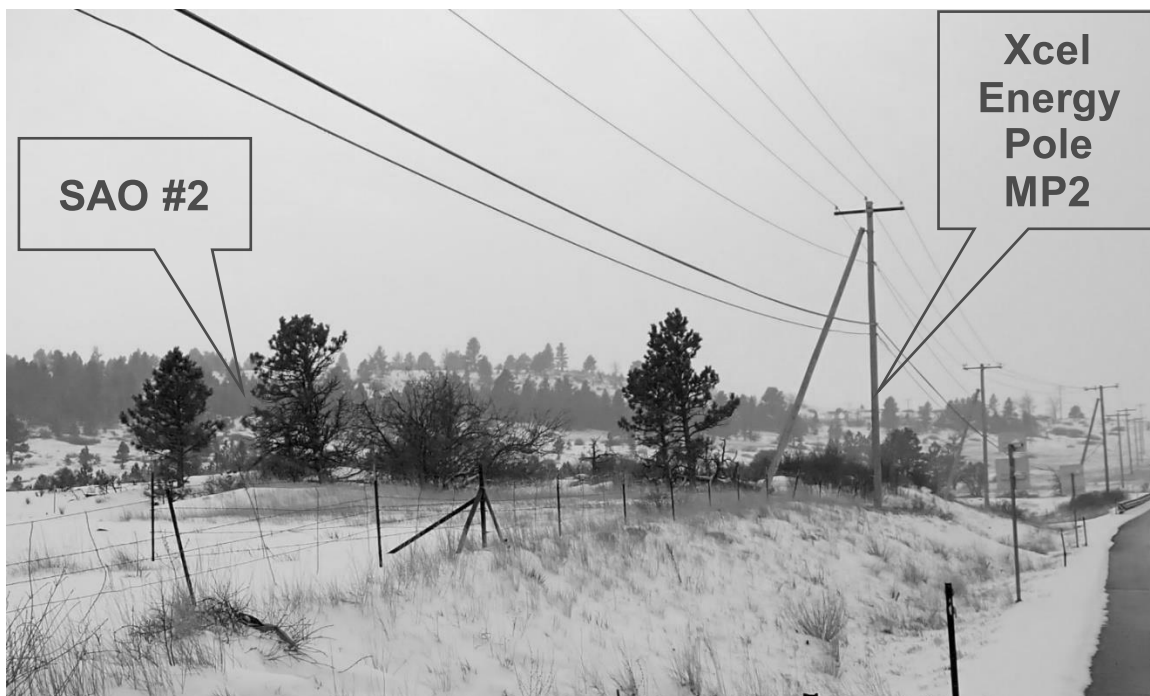
The Xcel Energy distribution line in the area of SAO #2 was supported by Pole MP2 (refer to Figure 16 through Figure 18.) The Xcel Energy system in the area was a three-phase, 33kV distribution line. Each conductor of the three-phase line was supported by a pin-type porcelain insulator and the conductors were lashed to the insulators with aluminum lashing wire (Figure 17 through Figure 20). The lashings from the east conductor that were found

Figure 16. Area of Xcel Energy pole MP2 image facing southeast.

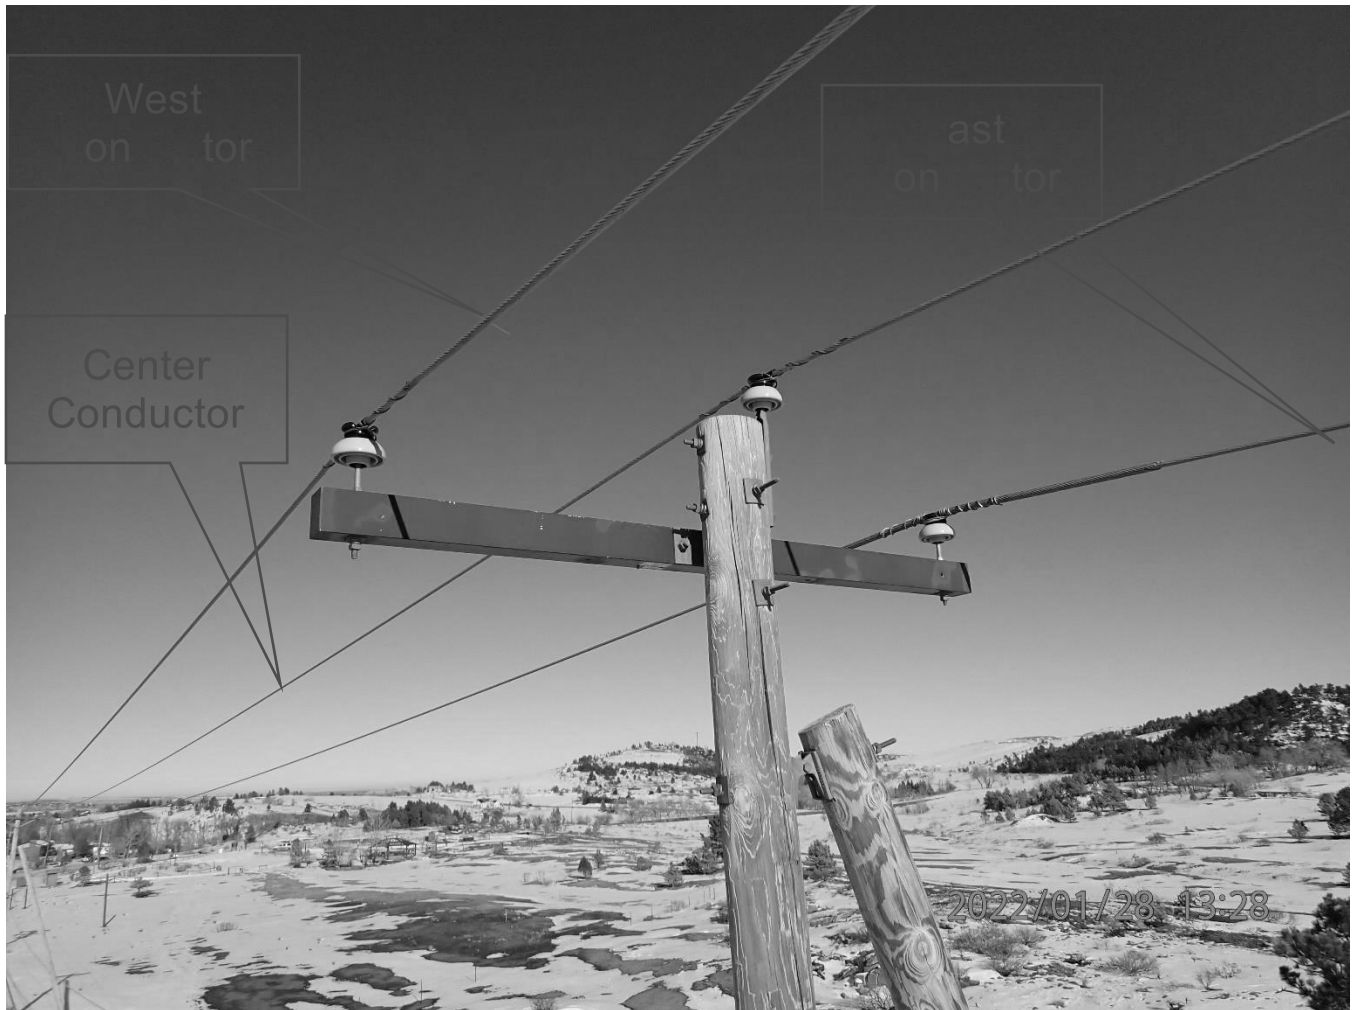
Figure 18. Crossarm and conductors at the top of pole MP2 facing northeast.

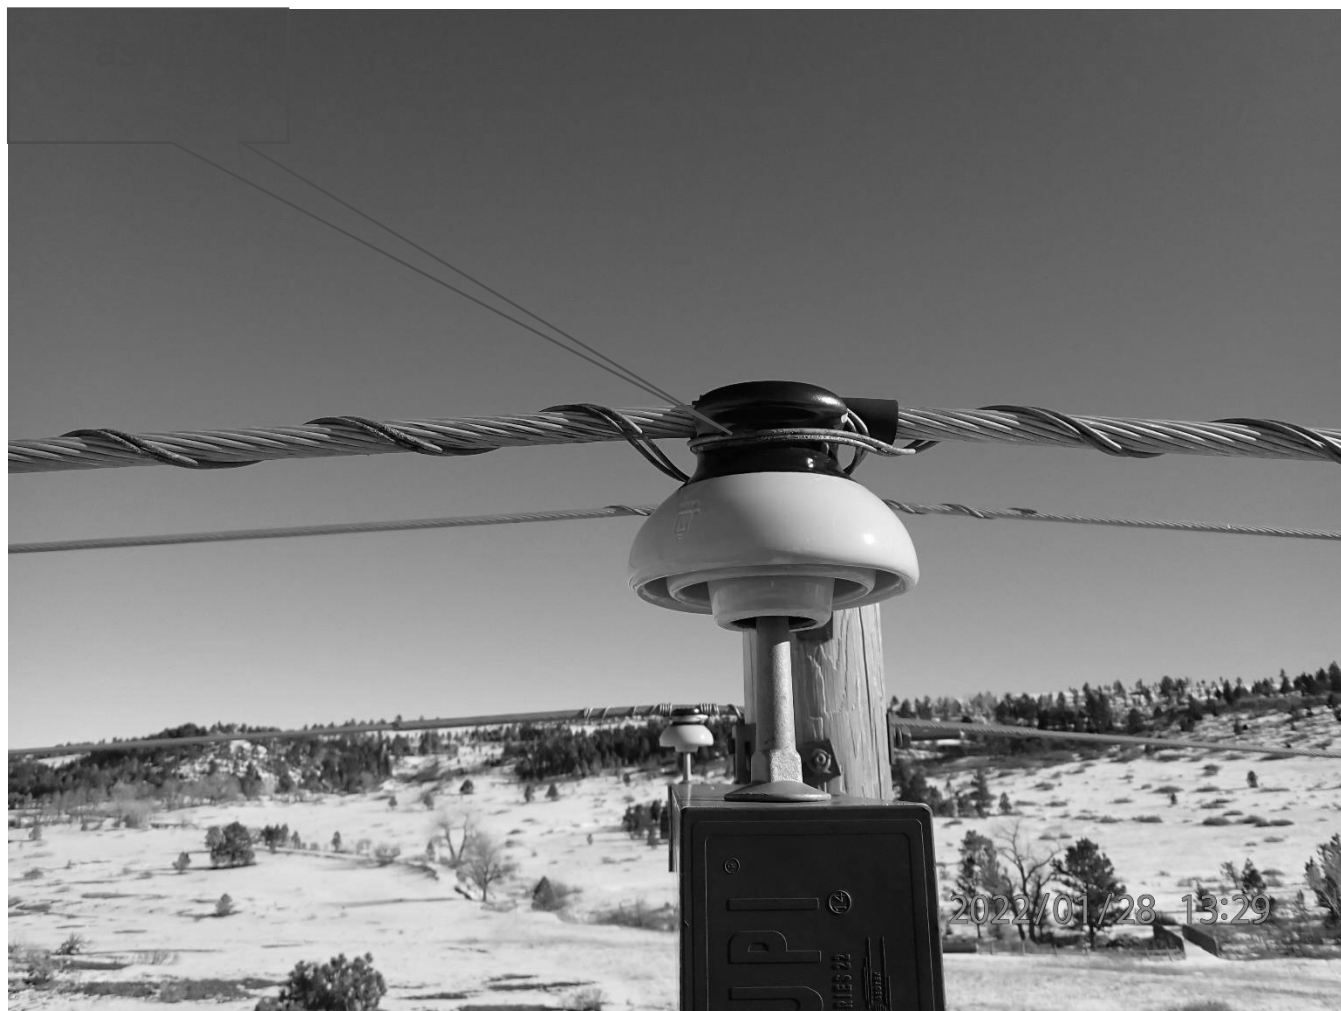
Figure 19. West phase pin insulator.

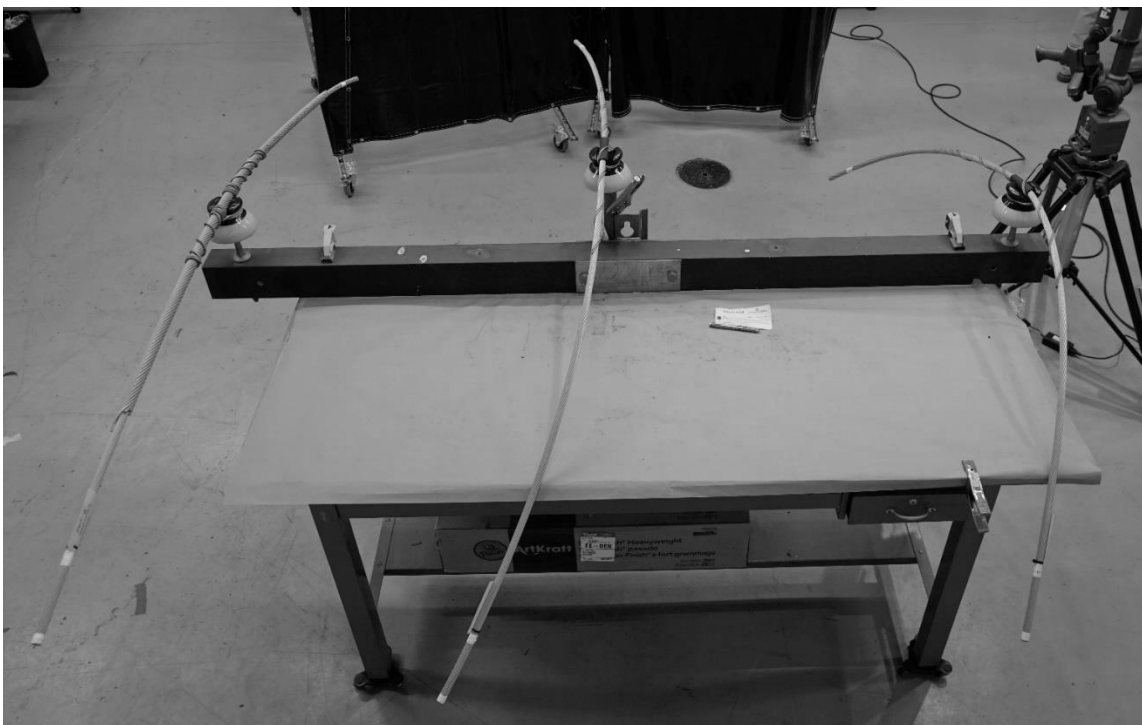
Figure 25. Crossarm and conductors reconstructed in the laboratory.
